DALLAS/FORT WORTH  
INTERNATIONAL AIRPORT

# SECURITY CHECKPOINTS Tiger Team 2006 Refinements and Appearance Guidelines

August 2006

PLANNING DEPARTMENT

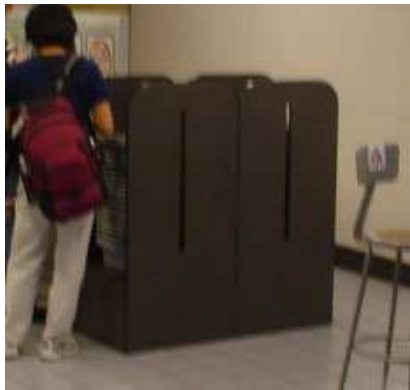
**Figure 1.** Bin Holder

- Backless bin holder design
- Provides easier access for the TSA to restock the bins
- Better bin availability at all divesting lanes
- As bin holder replacement is necessary, the new design will be installed

## BIN HOLDERS

C21 has two x-ray lanes, with dual divesting tables at each lane. The inboard divesting lanes are used by a majority of the passengers. The right inboard divesting lane handles the largest amount of traffic.

### Layout 1

The standard tub bin was replaced at each X-ray lane with the tall back less tub bins.

### Benefits

- Passengers placed their tubs on the divesting table perpendicular to the table length, increasing the utilization of divesting surface.
- Dark color hides dirt and stains.

### Issues

- Passengers did not notice the bins as quickly, possibly due to the darker color. May need to add graphics to the tub bins to increase visibility.
- Bins are easily moved allowing the TSA to change the layout. May need to bolt bins to tables to ensure they remain the correct position.
- Plastic laminate at bottom edge of bin is susceptible to chipping. With the dark color of the laminate chips are highly visible
- The TSA would forcefully load the bins. This created the potential for the tubs to slide out the back of the new bins.
- TSA were not comfortable stacking the bins as high with the backless design. They would stack excess tubs in front of the inboard side of the bins.

**Summary:**

Of the layouts tested, having one tall bin holder at each divesting lane was the most efficient. Items for consideration in the next bin holder design are:

- Lower the height of the tub bins by approximately 6". This will bring the top of the bins below the graphics of the divesting table sign graphics.
- Increase the size of the slit in the bin holder to 2" so the TSA can better see the tub level.
- Provide a 1" lip at the front of the bin so tubs will not slide out.
- Provide a partial height back to stabilize the sides of the bin.
- Provide a dark metal edge along the base to protect the P-lam from chipping.
- Provide graphic at the bins to help direct passengers to the outboard divesting tables.

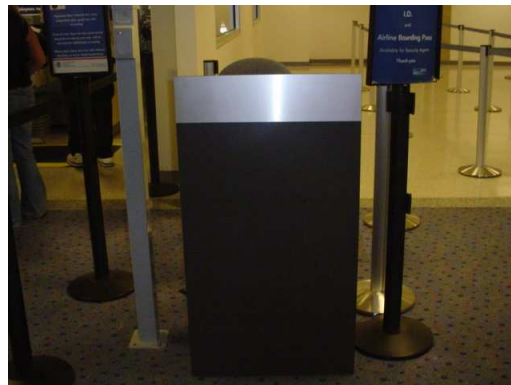
**Figure 2.** Podium

- Improves checkpoint appearance
- Provides a useful and comfortable workspace for the ticket checkers (See [DFW Airport Security Checkpoints: Appearance Guidelines](#) for podium specifications.)

## PODIUMS

We replaced the existing ticket check podium with a prototype.

### Benefits

- The height worked well with the stools used by the Prospect agents.
- The writing surface material was preferred by the Prospect staff to that of the prior podium.
- There are no doors on the back side of the podium.
- Dark color hides dirt and stains.

### Issues

- The adjustable shelf is supported by plastic clips.
- There is not a place for the file folder Prospect keeps at the podium.
- Plastic laminate at bottom edge of podium is susceptible to chipping. With the dark color of the laminate chips are highly visible.

### Summary

- Use a fixed shelf to increase durability. Shelf should be mounted high enough so that it is not used as a foot rest.
- Install a 12" high piece of material to act as a foot rest. Foot rest should have a metal edge for durability.
- Install a pocket, sleeve or shelf to hold Prospects file folder.
- Provide a dark metal edge along the base to protect the P-lam from chipping.

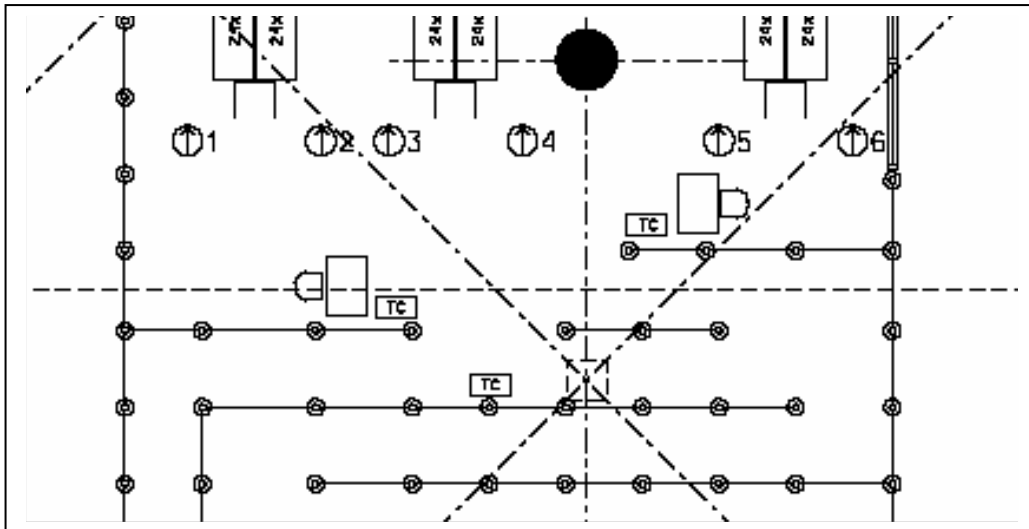
**Figure 3.** Queue split just prior to ticket checker. Ticket checker spread locations to prevent blockage (TC refers to 'Ticket Checker' location).

- Split queue line just prior to ticket checker
- Separated ticket checker locations to improve visibility and accessibility
- Provided additional clear space around ticket checkers to allow groups to pass
- Provided one bin holder for every 12 linear feet of table space
- Requested that ticket checkers direct passengers to open lanes
- Requested that TSA place tubs where needed, rather than closest bin holder
- Ensured amount of table top space maximizes divesting w/out impeding flows

- The queue line was split just prior to the ticket checker. This prevents delay and passenger backup that results from a single ticket checker location.
- The split line allows passengers to bypass large groups such as families that may need additional time for the ticket checker to verify their identification and to access an available ticket checker.
- Ticket checkers were encouraged to direct passengers to open lanes on both sides of each divesting table.

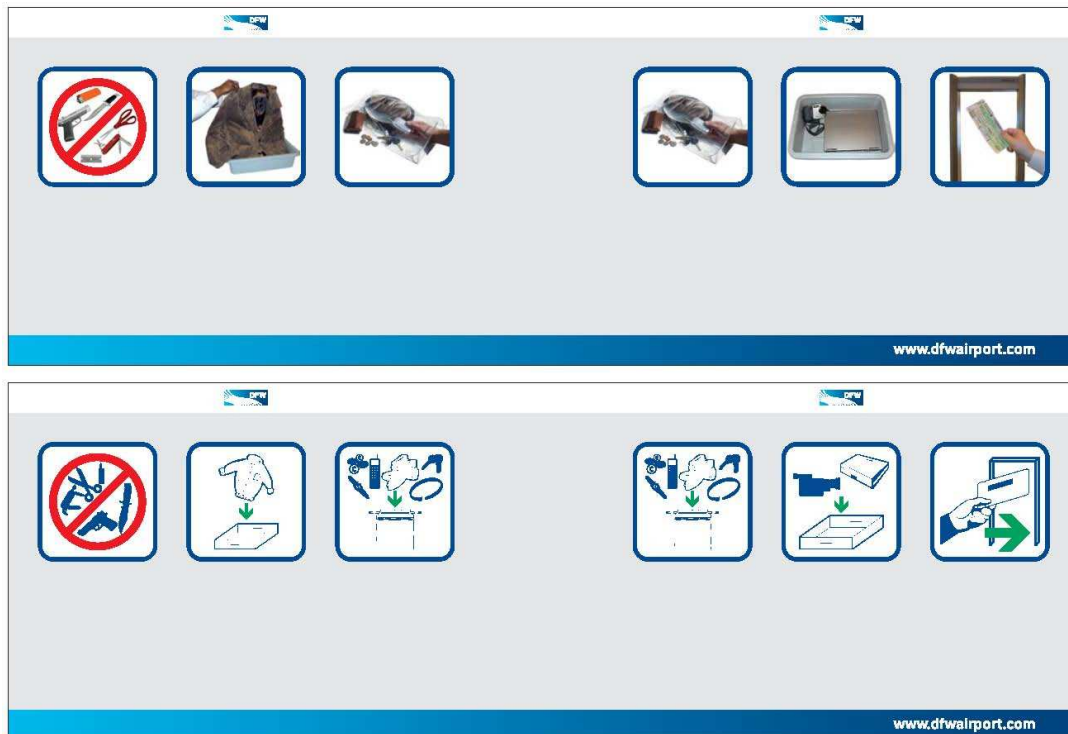
- Pictograms on existing divesting signs were replaced with photographs.
- Photographs more clearly depict the divesting process. See *Figure 4* below.

**Figure 4.** New photographs (top) replaced previous divesting pictograms (bottom) from 2005 study.
